Building & Grounds Manual

November, 2011

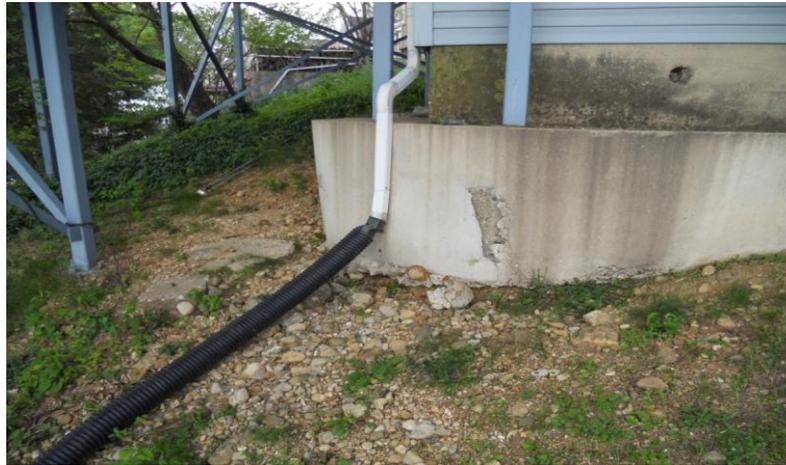
Gutters need to be cleaned each fall. Water spilling over the gutters in the corner of the deck washes down and has entered the basement due to a open area in the siding under the deck. The gutter in the corner of deck has disconnected in the past and washout area has occurred with soil eroding. This was redone in 2014 by Greg Byram and concrete was set at the base of the pipe to prevent further erosion. The vinyl pipe does clog up due to leaves getting into the gutters. Gutters above the deck should eventually be replaced with larger gutters and/or Gutter Helmut installed to keep leaves out of the gutters.

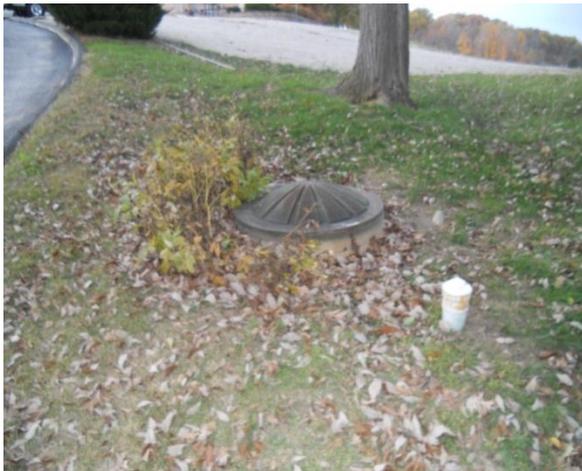
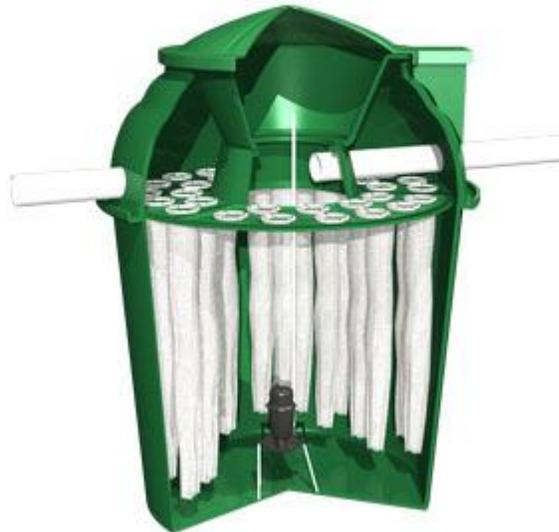
MULTI-FLO

We have a Multi-Flo home aeration system (750 gallon) that is located north of the blacktop going down to the lake. Current average water usage is about 500 gallons per work day assuming a 5 day work week. Needs chlorine tablets added at the white PVC pipe opening just east of the aeration system so the water leaving the system is treated. Manager takes care of this. The aeration system has 30 “cloth socks” that need to be cleaned every 90 days or so. Troy Drennan does this as well. We purchased a replacement motor for the Multi-Flo aeration system in Jan of 2012 and a new set of “socks” to make it easier to rotate them around and get cleaned. Pump was \$550 and a set of socks cost \$728 from Supeck in Ohio. Drennan stores these for us and cleans them. Multi-Flo phone 888-725-0209. Serial number of pump is 110520046 and has a 2 year warranty. Pump is a Maxair 500. www.maxair500.com or www.septicsserv.com

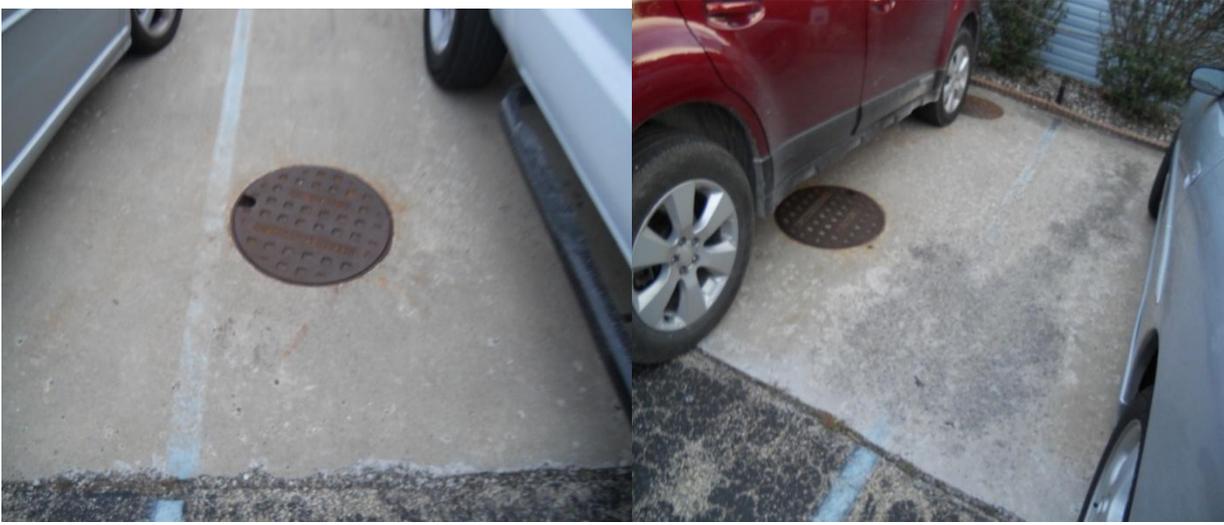
We have 2 “dousing tanks” and one grease trap located outside under the handicapped parking area north of the restrooms that were installed by Drennan when the restroom addition was built. These tanks have pumps that move waste from one tank to another, then finally down to the aeration system. These units probably should be on AUTO as they have float valves that start pumping when they reach a certain level to move waste down to the septic system gradually for decomposition.

Troy Drennan (cell 304-2521) regularly pumps from these tanks to avoid problems.

Both sewer systems have alarm systems in the dish room beyond the dishwashing station. Instruction booklets can be found there as well. There is a grease trap in the dishwashing room and a large one outside. We should consider adding a small pump that will insert bacteria into the grease trap to minimize the amount of grease into the septic. Drennan can clean these as well.

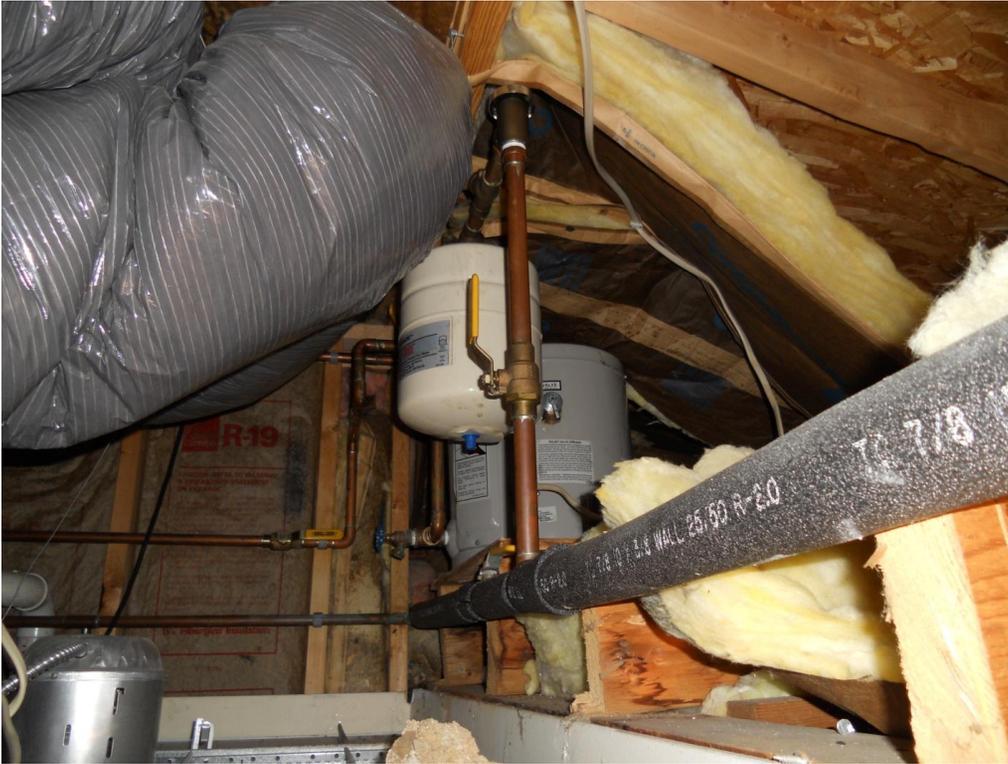
There is a small electric water heater (picture below) above the east wall of the women's rest room with access inside a stall. There is a shut off valve before the water heater as well as a circulation pump. **Water too hot in the restrooms?** Someone didn't turn off the outside hose by the back steps by pushing it in all the way.
